Interim Report

Monitoring and Evaluation of Thin Bonded Overlays and Surface Laminates for Bridge Decks

Dave Johnson

August 1997

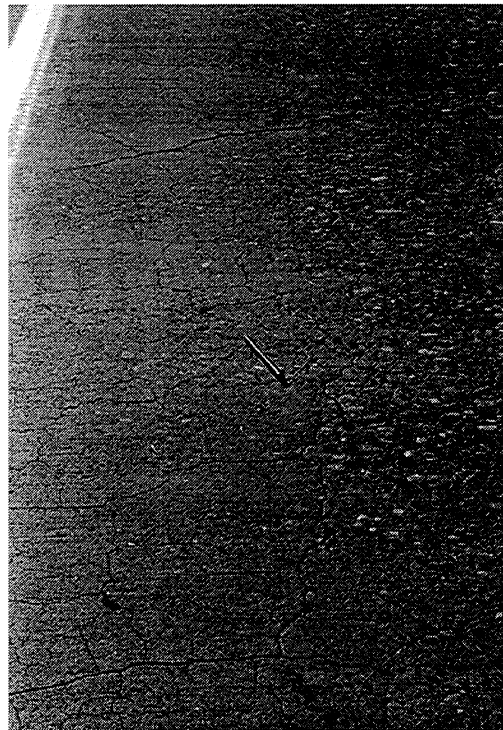
Photo 2: Pre-installation, typical driving surface, Gallatin.

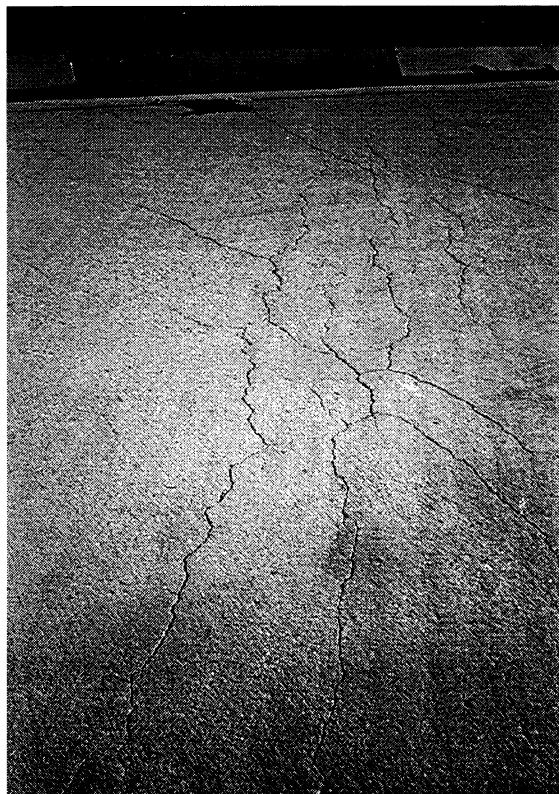
Photo 6: Pre-installation, typical driving surface, West Garrison.

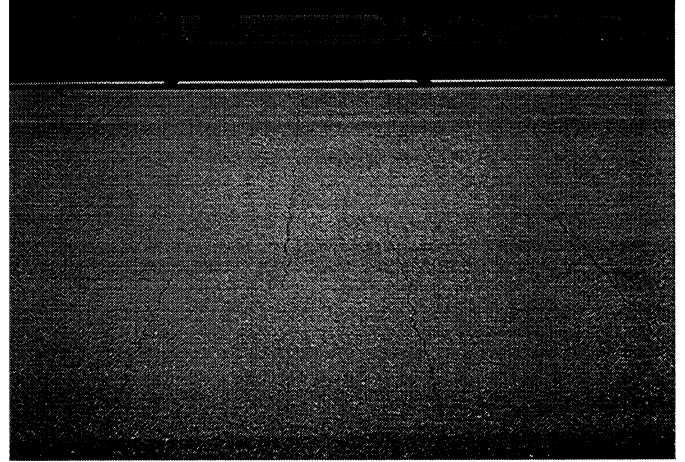
Photo 15: Pre-overlay, surface, East Garrison.

application of the first lift to the westbound driving lane. Silica from the sandblasting was still present in the existing popouts in the original deck surface when this lift was applied. For the second lift, increasingly ominous skies stopped the contractor at mid-span. Work on the second lift resumed the next morning. Water from the rains of the previous night was removed using a propane torch.

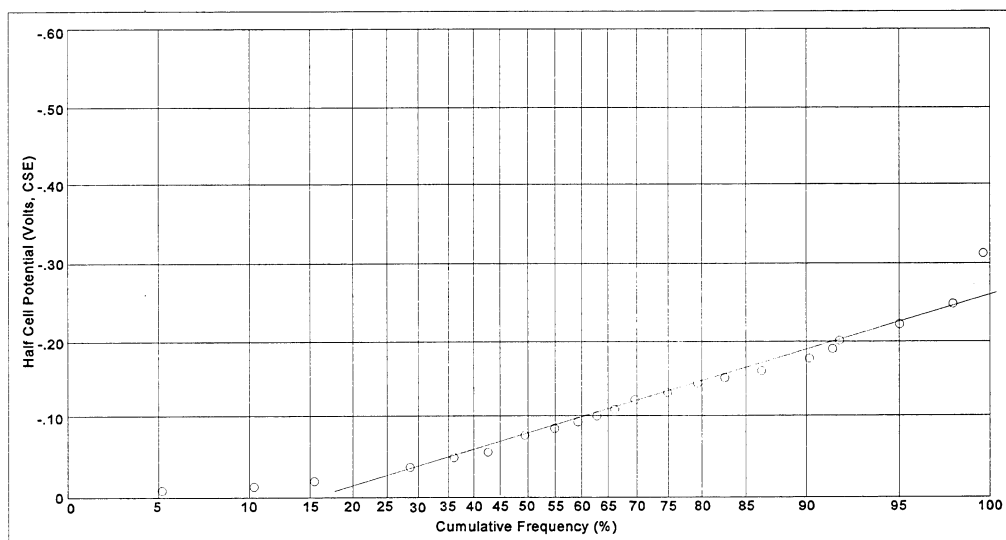
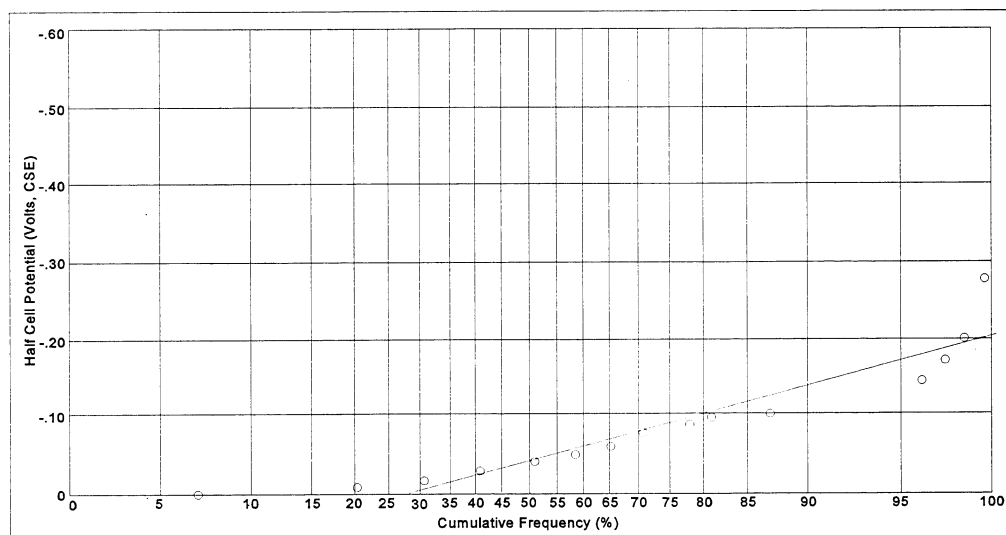
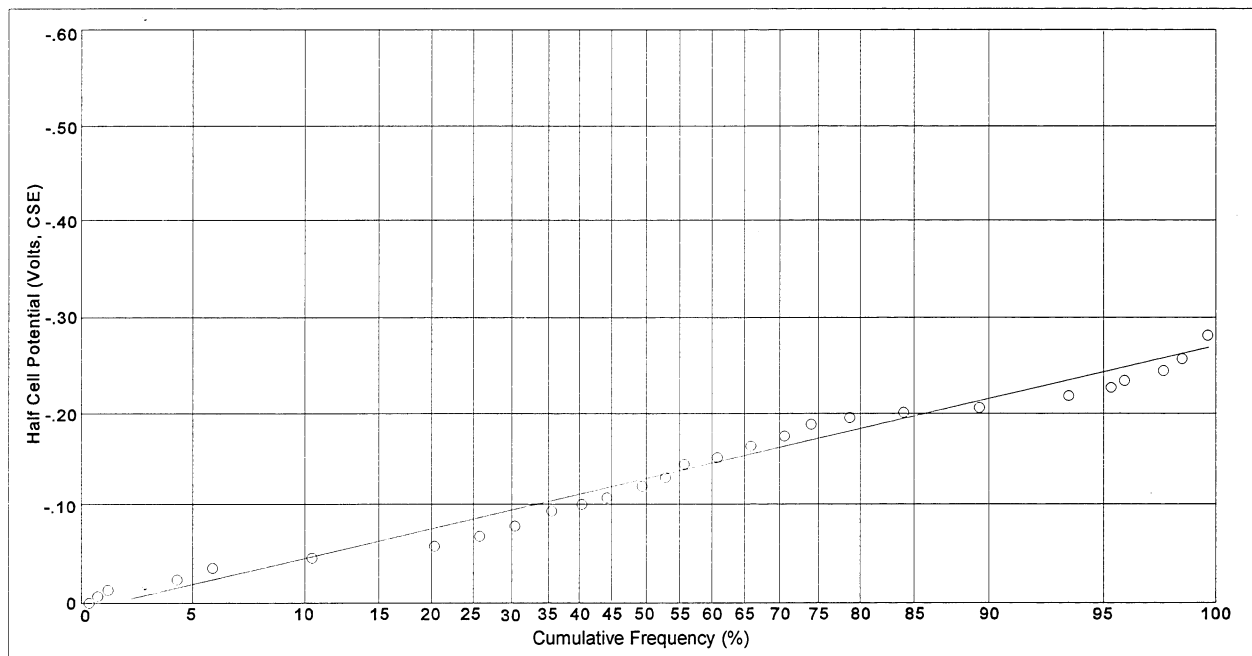
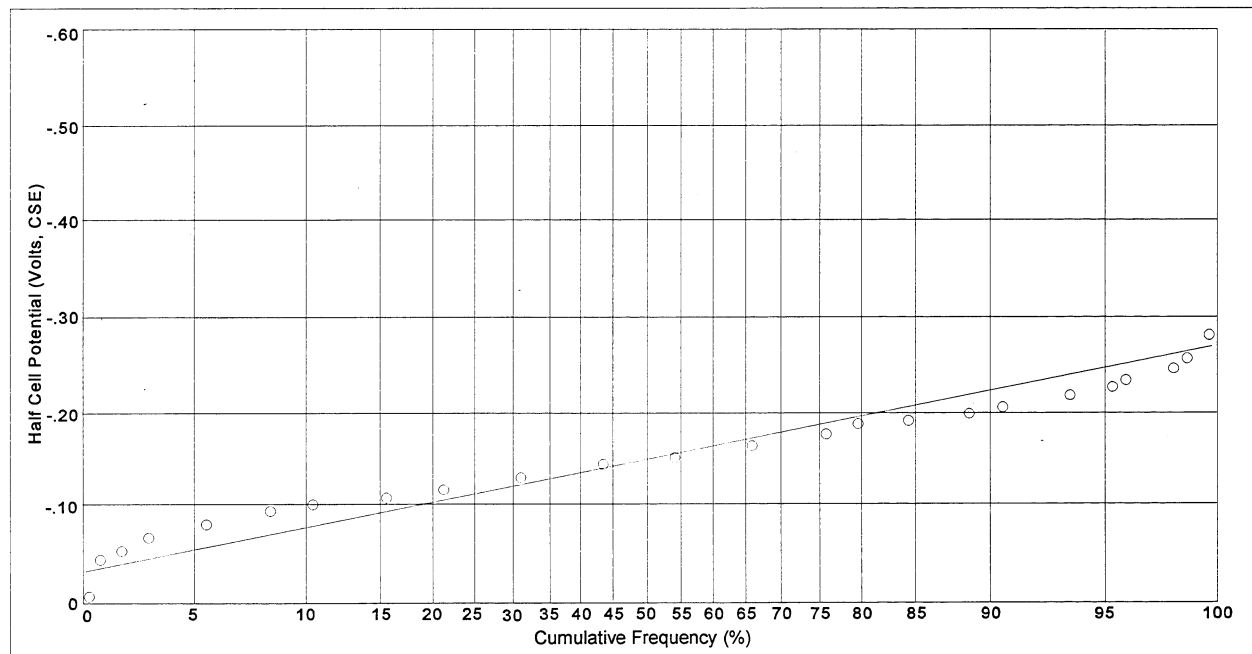
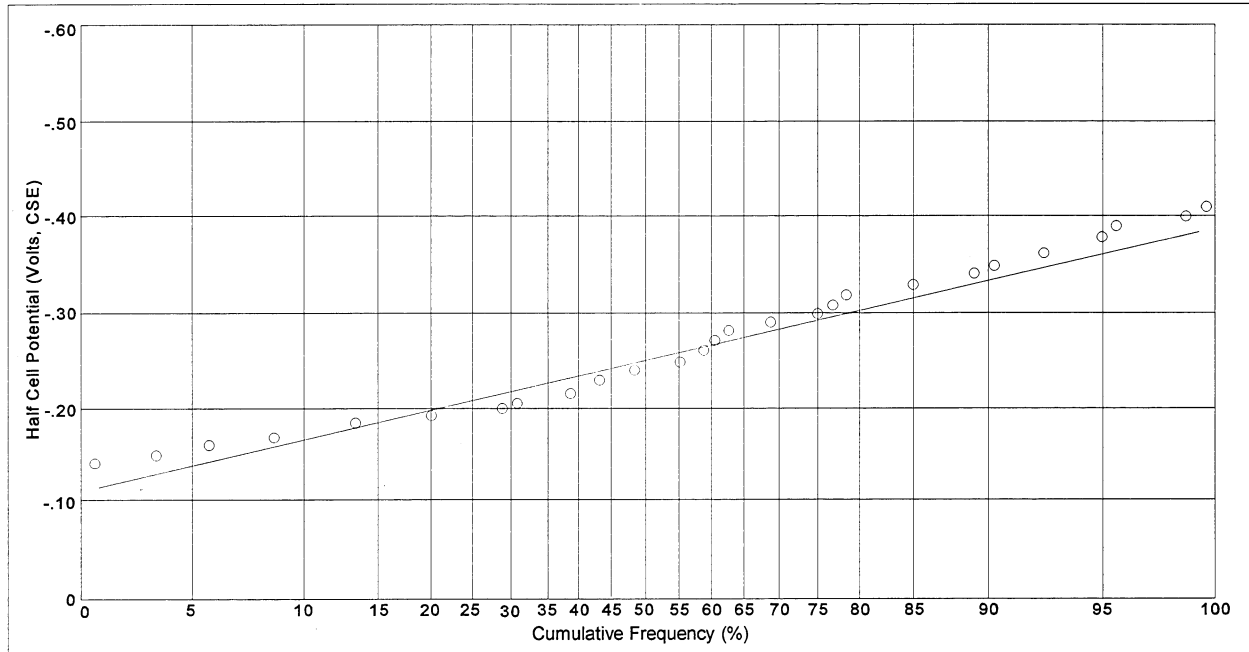
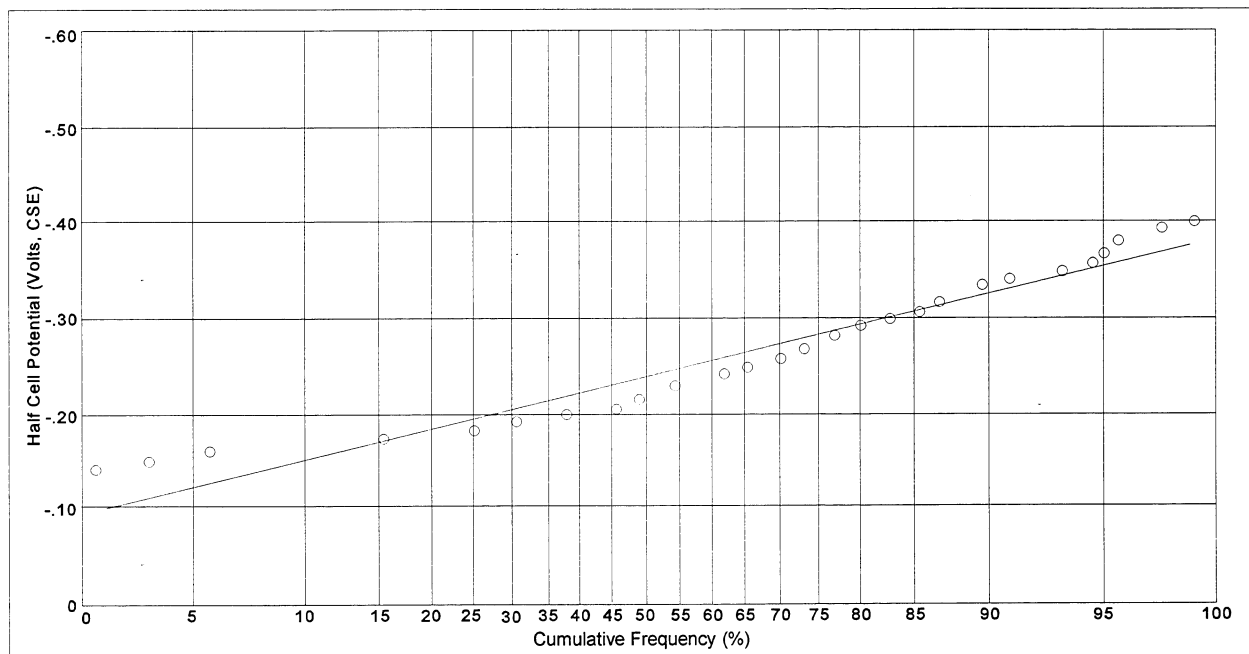
thresholds, the occurrence of corrosion is uncertain. Reviewing Figures 4.1.5 to 4.1.10, the occurrence of corrosion is unlikely over most of the West Garrison and Gallatin structures, as at least 85 percent of the reading were above -0.20 V CSE and 100 percent of the reading were above -0.35 V CSE. Some of the readings from the Galen structures indicate that corrosion was likely to have been occurring on parts of the decks when the readings were taken. Readings that would indicate corrosion activity (< -0.35 V CSE) occurred over approximately 7 percent of the deck surface.

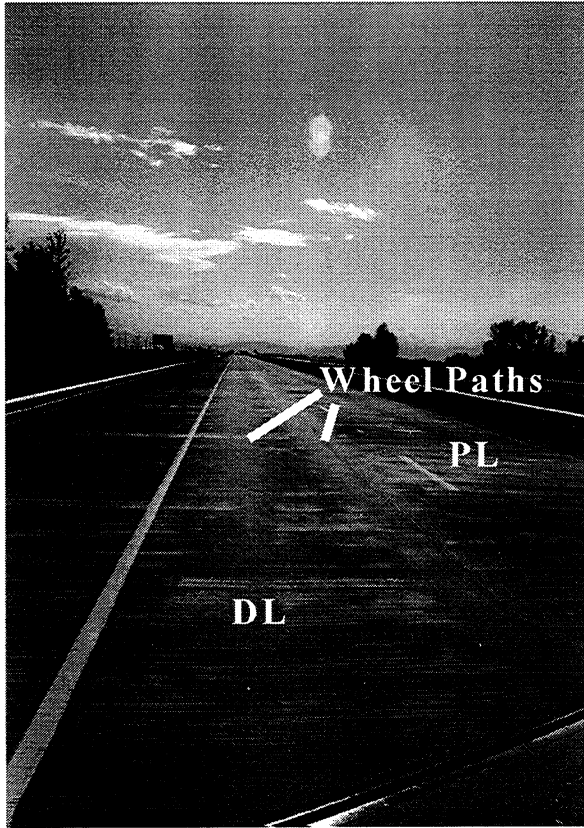
Photo 20: Gallatin westbound, looking east.

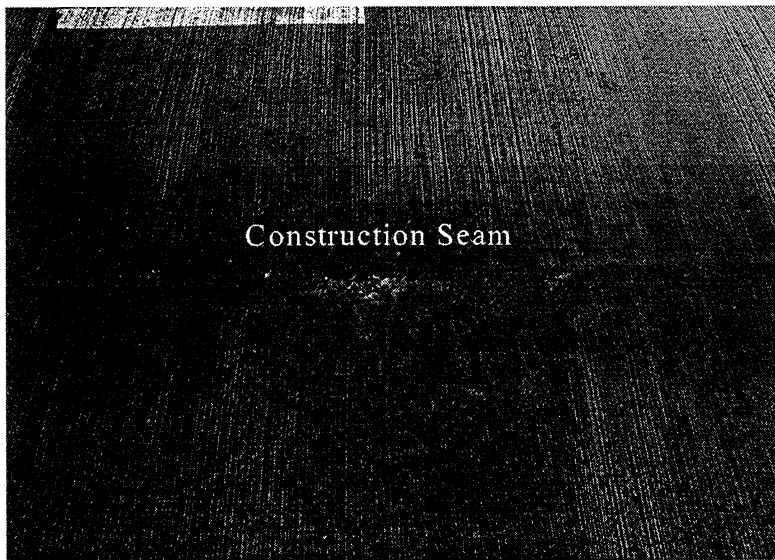
Photo 21: Gallatin, surface condition.

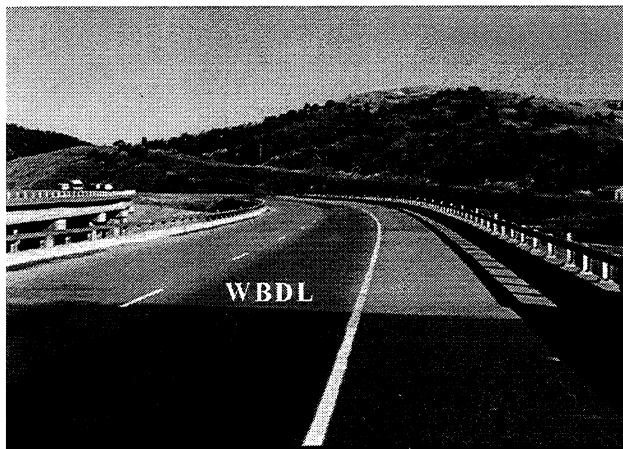
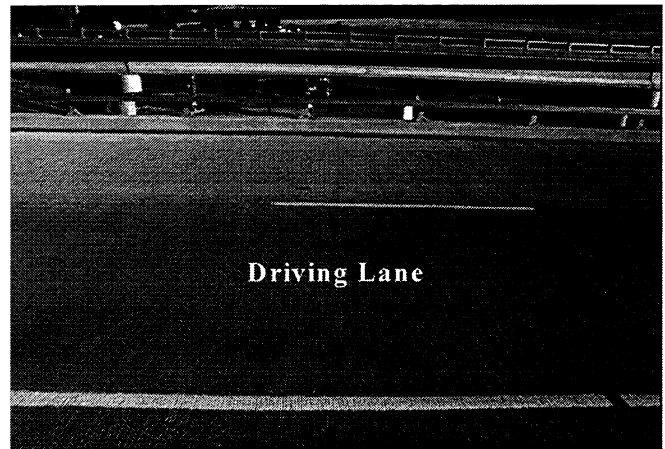
Figure 5.1.2 shows the condition of the Thorotop HCR structures at the West Garrison Interchange at the time of their first annual evaluation. Many of the distresses noted for the Gallatin bridges were also observed on these structures. Wheel paths were evident in the driving lanes. The pattern of smoothness observed in the wheel paths was similar to that of the Gallatin bridges. A number of delaminations were noticed at the expansion and construction joints. Additional delaminations were seen on the shoulders and on the driving surface on the westbound structure. Further analysis of the delamination locations revealed no correlation with pre-installation distresses. Marring from snow plow activity was seen. No cracking was observed on these bridges.

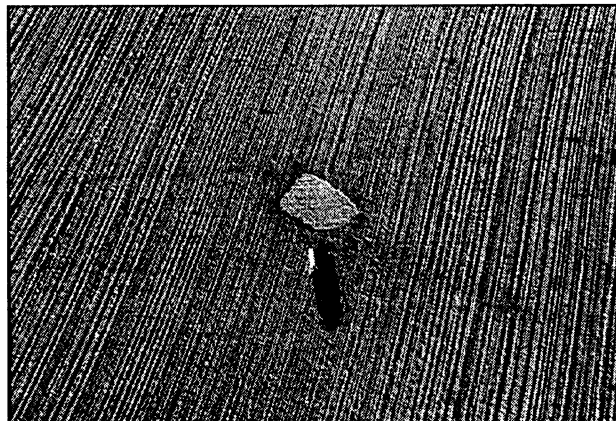
Photo 24: West Garrison, delamination.

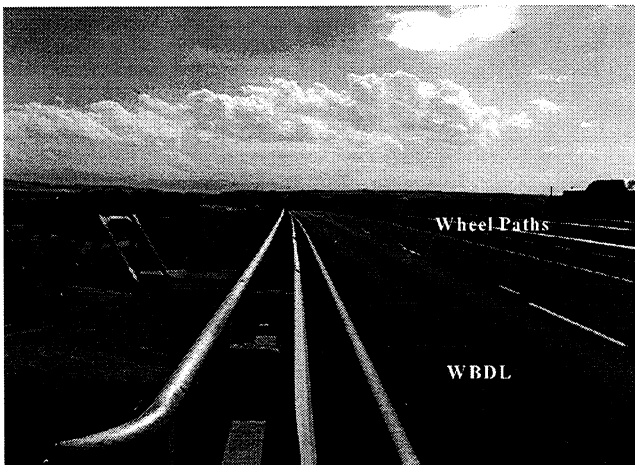
Photo 25: Madison, westbound.

The first of the Flexolith 216 bridges evaluated was the westbound bridge at the Madison River near Three Forks (see Figure 5.1.3). As had been the case with all of the Thorotop HCR bridges, wheel paths were visible in the driving lanes, and the surface of the deck was smoother in these areas compared to the rest of the structure. This smoothness appeared to result from the loss of surface aggregate in the wheel paths. None the less, the Flexolith 216 wheel paths were noticeably rougher to the touch than the Thorotop HCR wheel paths. Areas where the aggregate coverage appeared inadequate at the completion of construction were conspicuous after one year. All construction seams were visible. Some reflective cracking could be seen above two of the bents in the driving lanes. An oval shaped crack, 12 inches by 18 inches, was found on the west end of the passing lane (see Figure 5.1.3, Photo 26). Surface marring, perhaps from snowplowing, was also seen. This marring was less extensive and less severe than was observed on the Thorotop overlays.

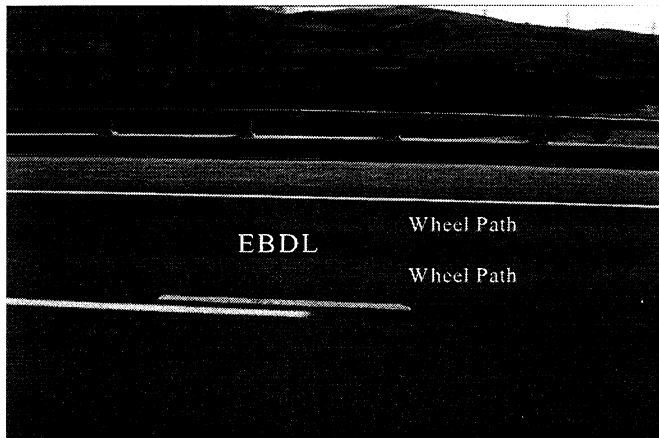
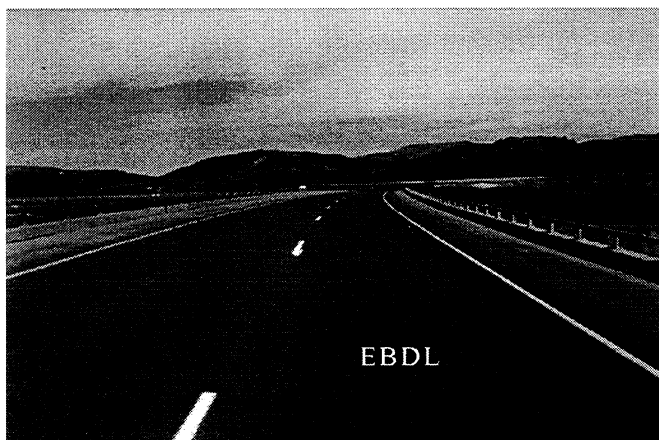
The westbound and eastbound East Garrison bridges had many of the same distresses as had been seen on the Madison bridges. Removal of aggregate in the wheel paths once again resulted in a visibly smoother surface in these areas. A minimal amount of snow plow marring had occurred on both structures. No cracking was seen. Figure 5.1.4 further documents the condition of the East Garrison bridges.

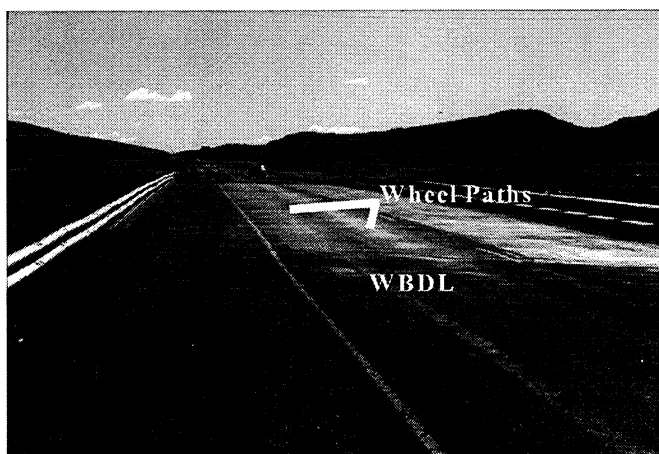
Photo 29: Fairmont - westbound.

The only structures evaluated in 1996 that had received a Degadur MMA overlay treatment were those near the Fairmont Interchange. Both of the eastbound and westbound structures at Fairmont were performing in a similar fashion. While wheel paths were evident in the driving lanes, from general wear, the surfaces of the bridges were uniformly smooth to the touch across the entire structure. This condition appeared to be a result of the seal coat more so than poor aggregate coverage or removal. Popouts, as described in SHRP-P-338 (15), were noted on the surface of the overlays of both decks. Delaminations were found on both structures. Three delaminations were located on the westbound bridge; only one, on the eastbound bridge. While the sizes of these delaminations were not measured due to the high volume of traffic at the time of the evaluation, these areas were roughly 4 to 6 inches in diameter. The only crack found was on the westbound deck. It extended through the entire depth of the overlay at the approach guard angle.

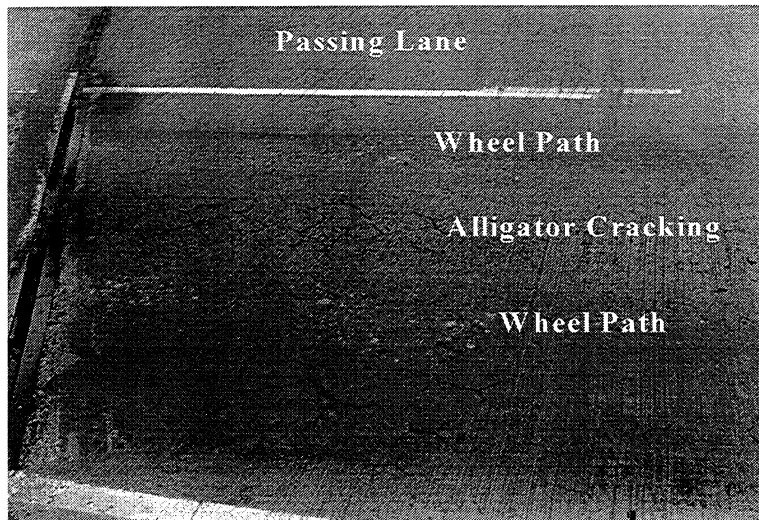
Photo 31: Gallatin, typical driving surface.
